Ultramark 4

ULTRASOUND SYSTEM

field service manual

Service Manual 4730-0001-06 Rev B consists of:

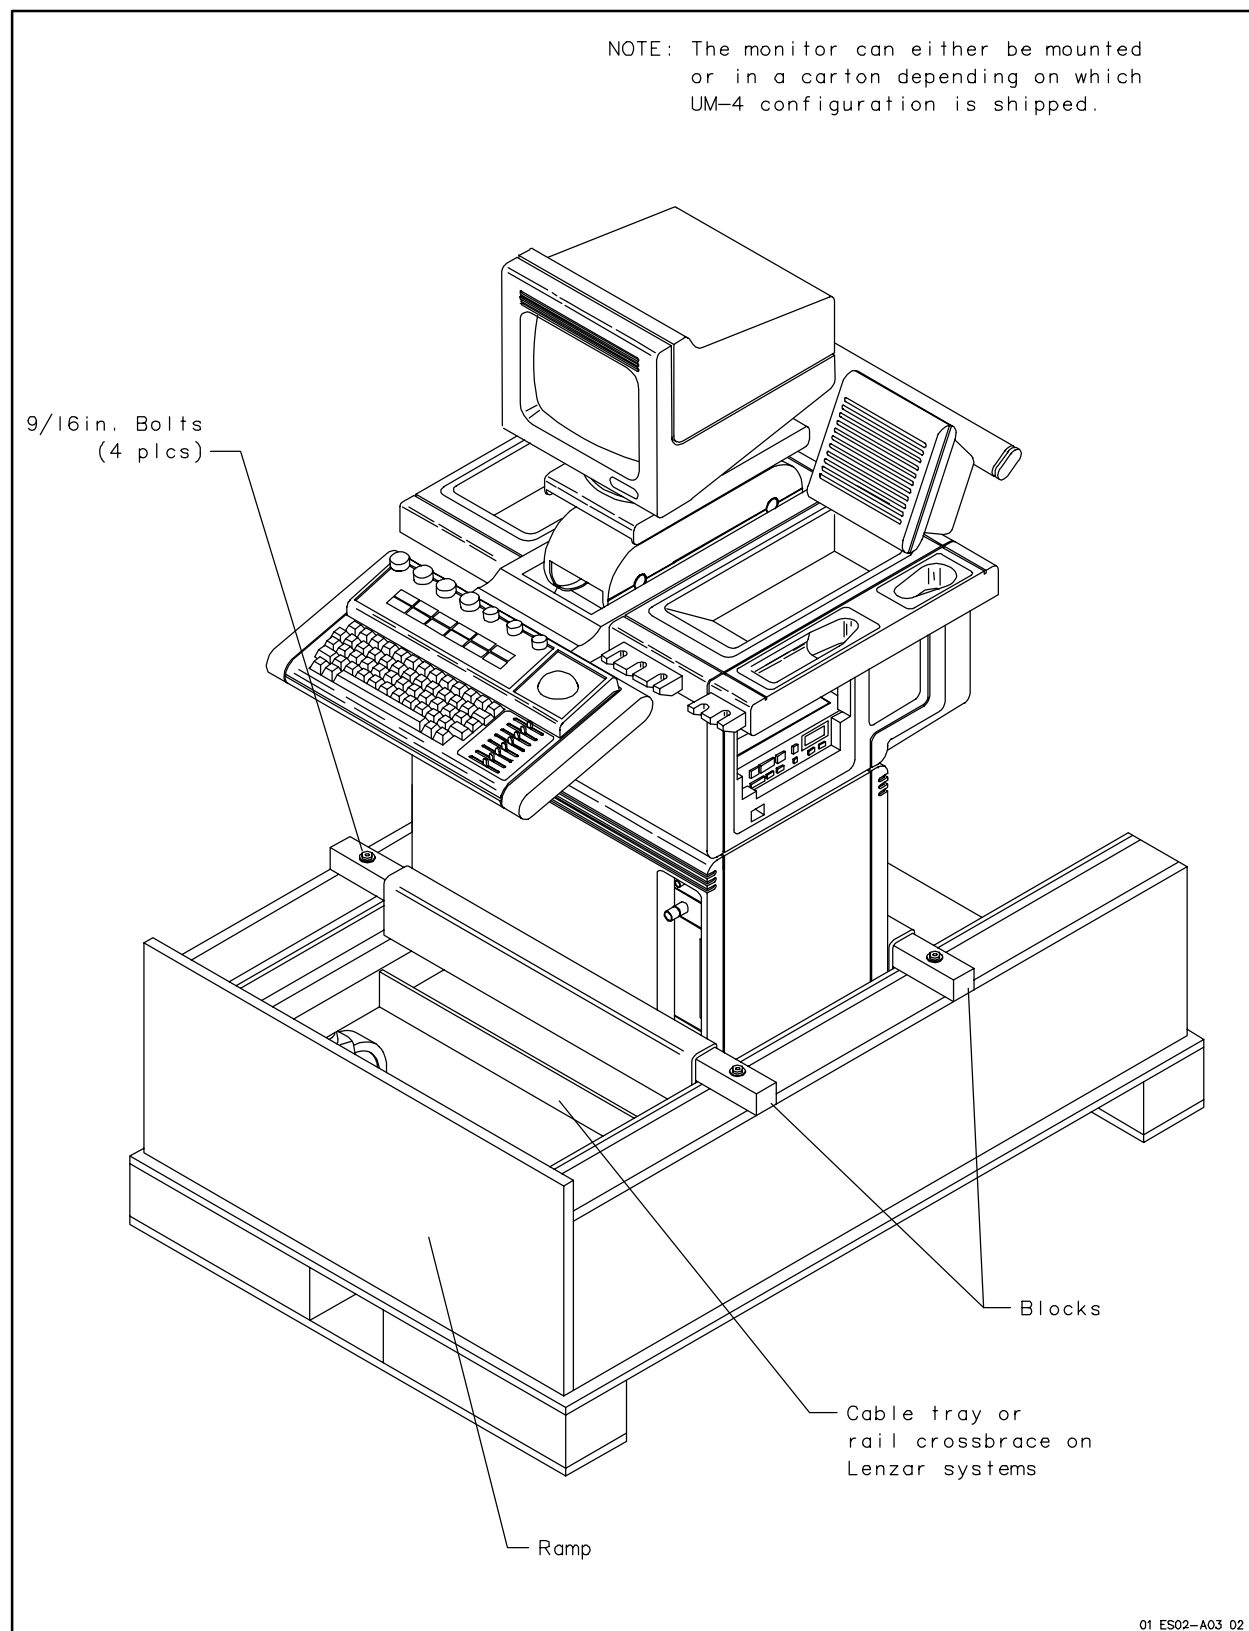
**Figure 2B-2. UM-4 on Shipping Pallet**

NOTE: The monitor can either be mounted or in a carton depending on which UM-4 configuration is shipped.

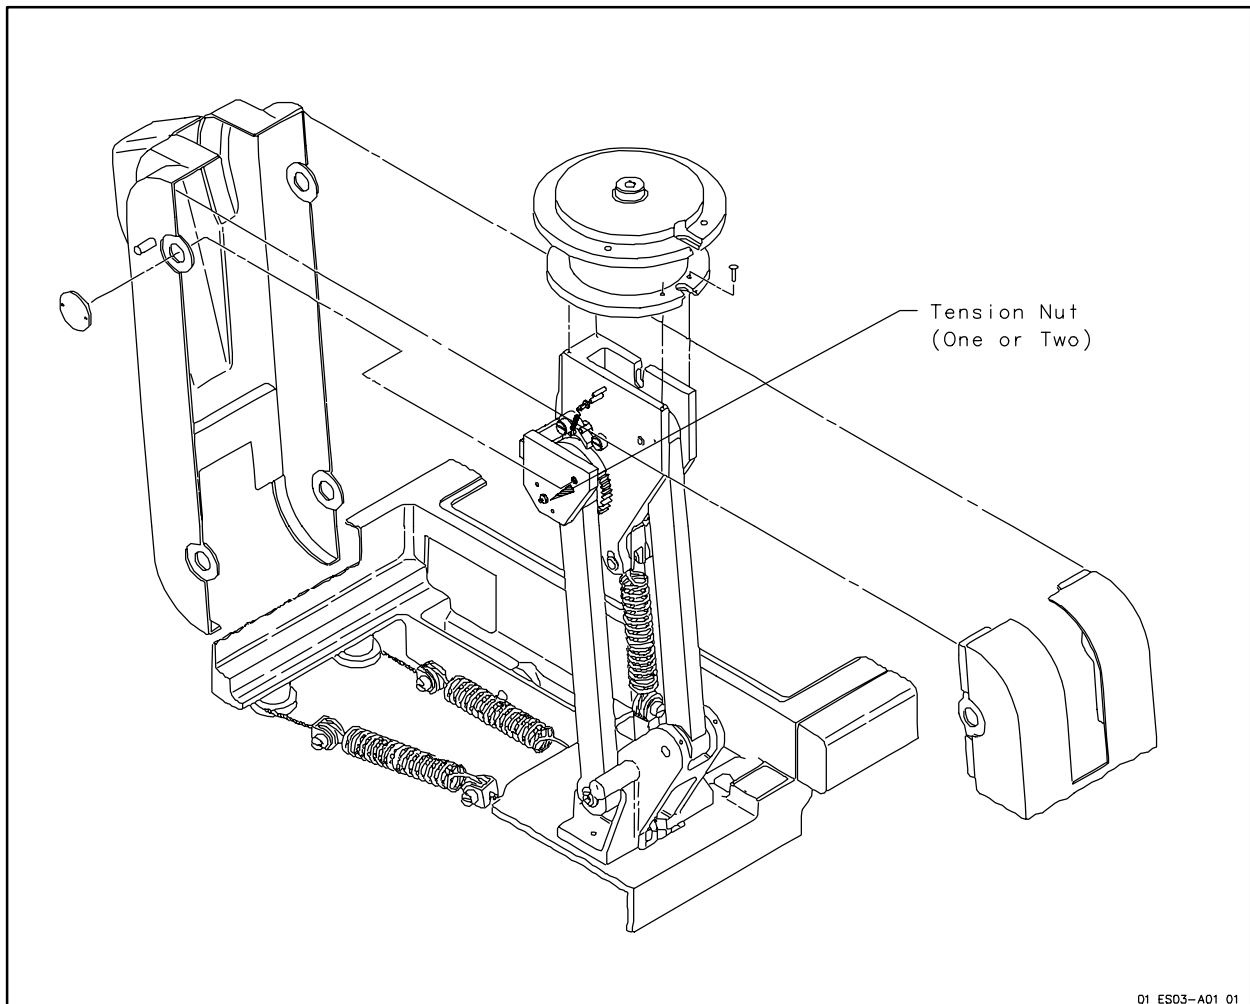
Figure 3-1. HFC Monitor Arm Tension Adjustment

1. Fully extend monitor arm. Remove upper and lower monitor arm covers.
2. Tighten tension nuts on arm to dampen movement (**Figure 3-1**).
3. Replace covers.

3-2 HFC Monitor Arm Tension Adjustment (Figure 3-1)

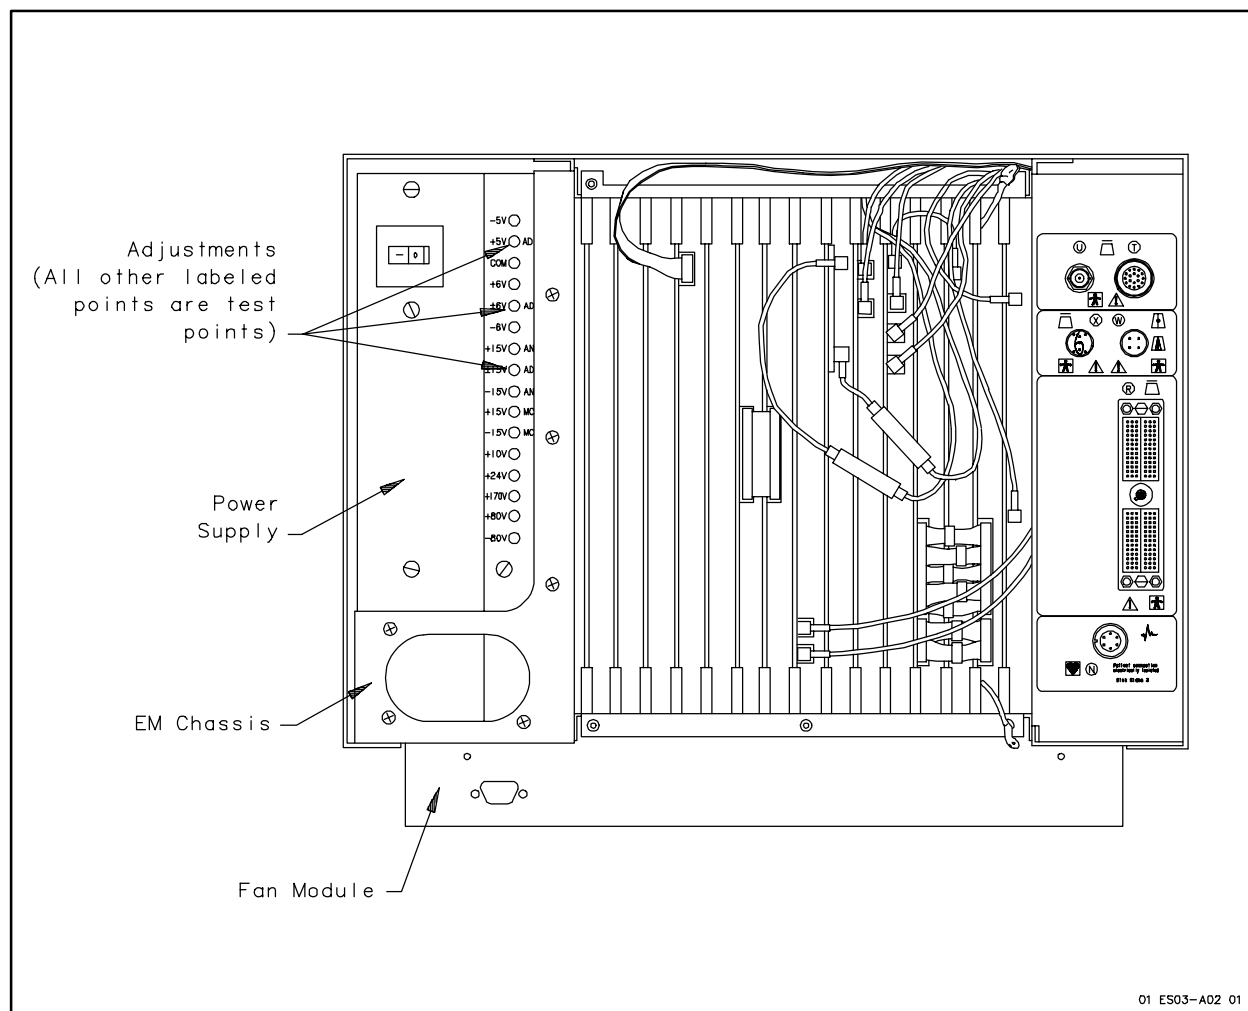
Figure 3-2. Power Supply Adjustment

1. Set system power to OFF and disconnect scanheads.
2. Remove front bezel and card cage shield.
3. Connect DVM common lead to COM test jack on power supply. Connect other lead to jack corresponding to voltage under test (**Figure 3-2**).
4. Check +5, ± 6 , and ± 15 (analog) volt outputs are according to specifications in **Table 3-1**. Adjust if necessary.

3-3 Power Supply (Figure 3-2)

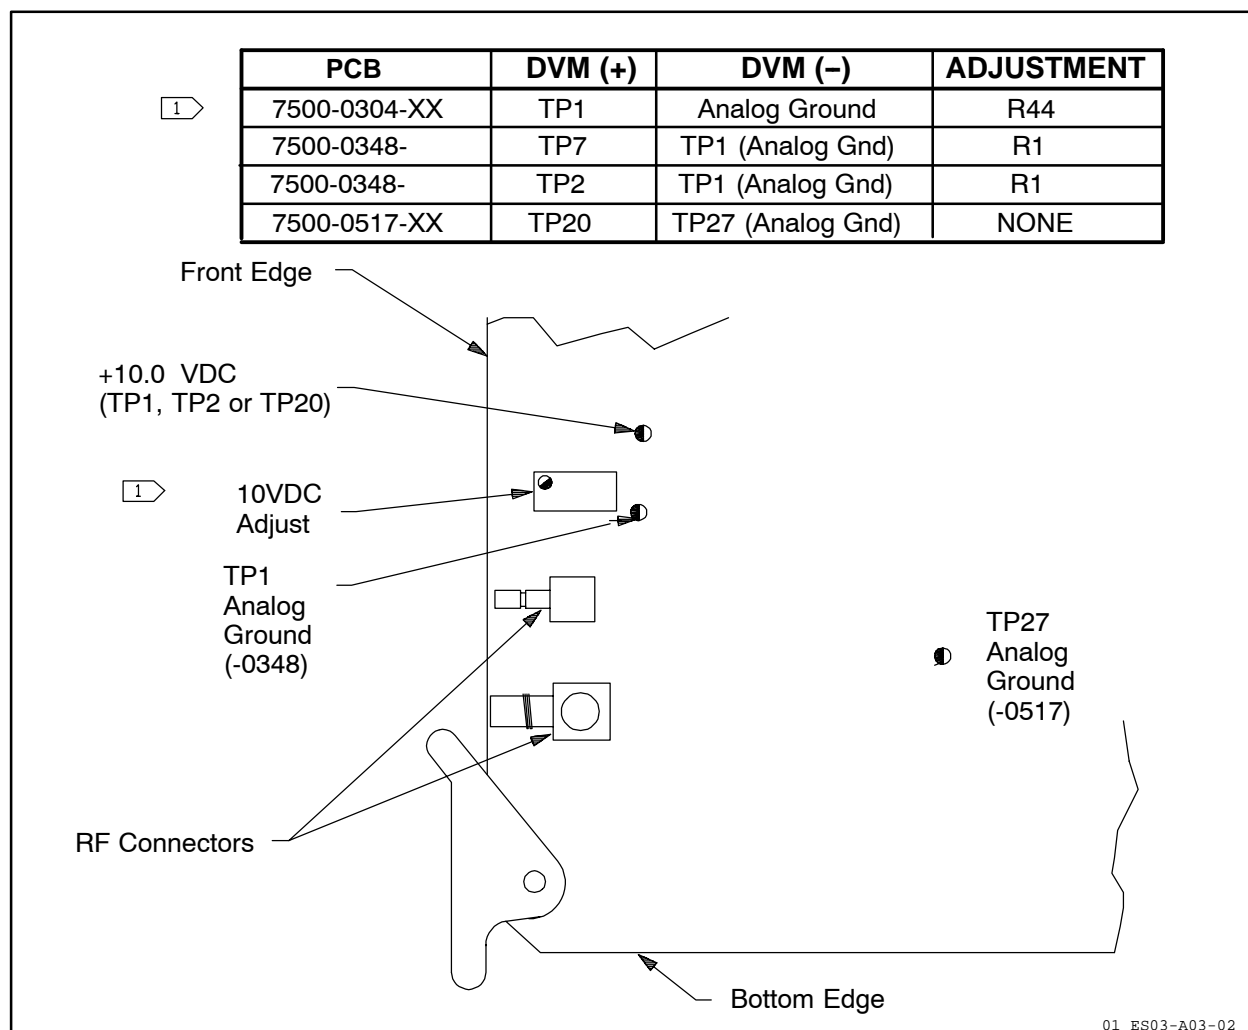
Figure 3-3. Motor Controller Adjustments

1. Set system power to OFF.
2. Connect DVM micro clips to 10.0V test point and ground on PCB A8, Motor Controller PCB (Figure 3-3).

5. Verify that the scanhead annotation displayed on the monitor matches the active scanhead.
6. Verify that voltage is between 9.995 VDC and 10.004 VDC. If necessary, adjust R44 to +10.0 VDC (7500-0517-XX PCBs have no adjustment pot).
7. Set system power OFF.
8. Remove test leads.
9. Verify that the RF connectors to PCB connectors are firmly installed on the PCB.
10. Replace the PCB if the voltage cannot be adjusted into tolerance.

3-4 Motor Controller (Figure 3-3) 7500-0348-XX

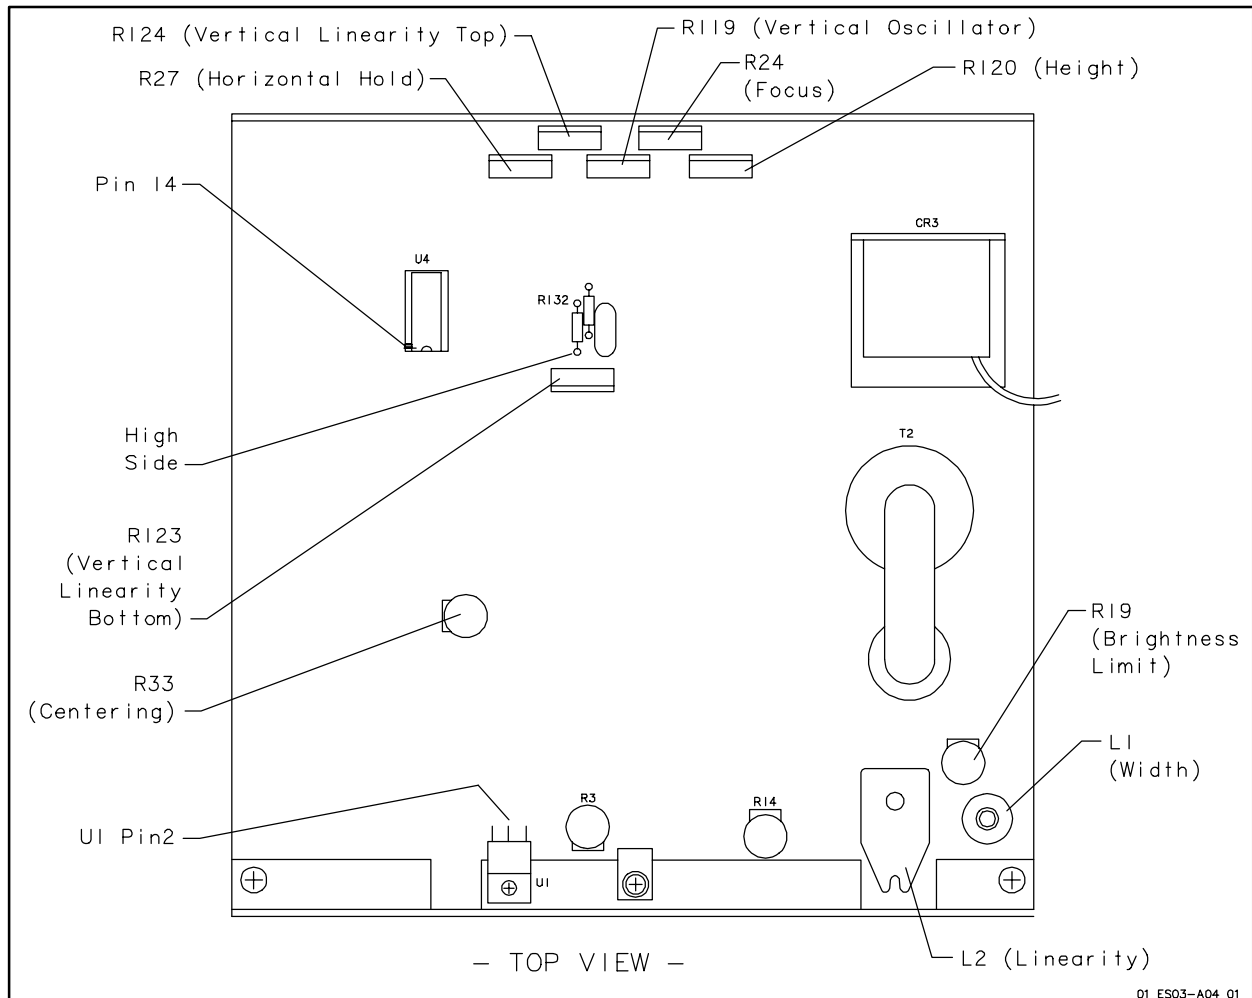
Figure 3-4. Old-Style Monitor PCB Adjustment Points

3. Connect oscilloscope to high side of R132 (**Figure 3-4**).
4. Adjust R119 (vertical oscillator frequency) for a waveform period of 17.5 msec (525-line video).
5. Remove oscilloscope leads and the ground from U4, pin 14.

NOTE: The old and new style monitors are easily identified by removing the monitor cover and comparing the PCBs with [Figure 3-4](#) and [Figure 3-6](#).

Linearity	Display		3-4	L2	Use VCR grid or caliper methods, Ref W 3-5.4
Width	Display	Verify width in Fig 3-5	3-4, 3-5	L1	Ref W 3-5.4
Phasing	Display	Center raster horizontally	3-4	R33	Ref W 3-5.4
Height	Display	Verify height in Fig 3-5	3-4, 3-5	R120	Ref W 3-5.4
Top Vert. Linearity	Display	Equal spacing between horiz. grid lines at middle/top of display	3-4	R124	Use VCR grid or caliper methods, Ref W 3-5.4

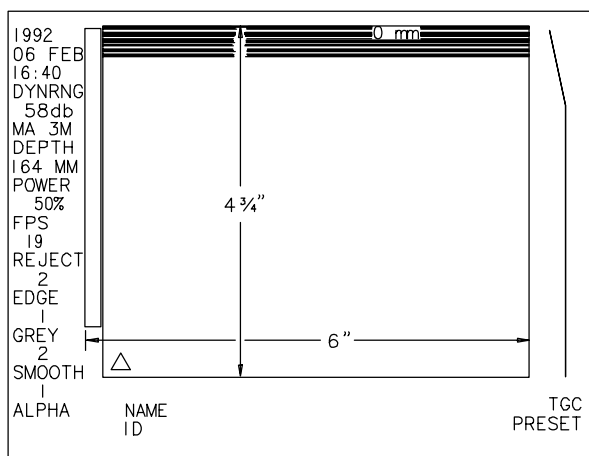
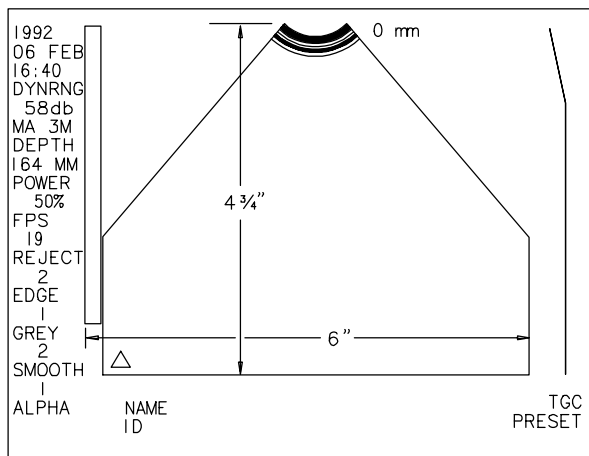
Figure 3-5. Ultrasound Image Measurement

1. Magnify the image using zoom control to make the right border of the ultrasound display visible.
2. Adjust L1. Verify distance between left side of gray bar and right border of the ultrasound display area measures 6.0 inches (**Figure 3-5**).

Adjust R120 so that height of the ultrasound display area is 4 $\frac{3}{4}$ inches (**Figure 3-5**).

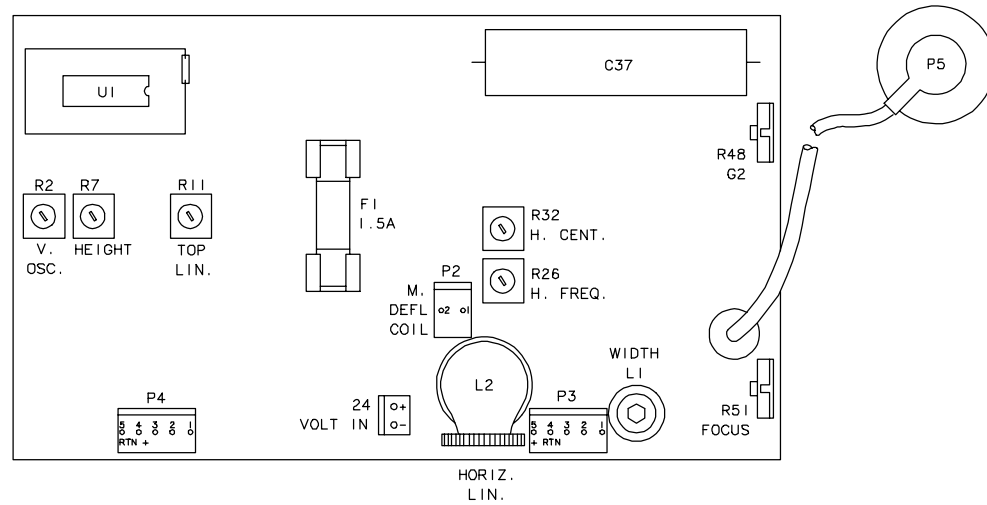
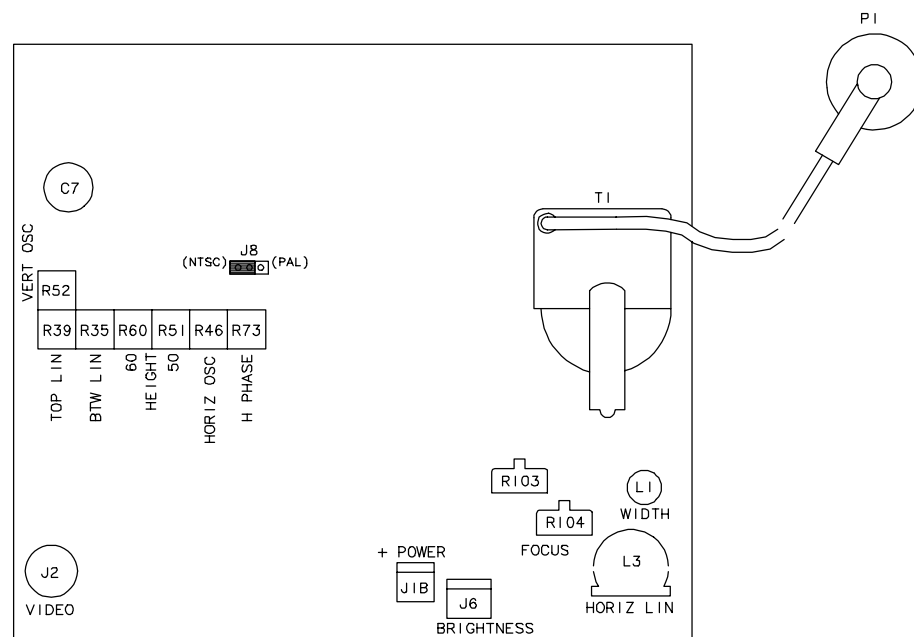
1. CRT Connector to E12, E7, E8, E9, E10, E11 Not Shown
2. Fuse F1: Bus Max 1 1/2A, Slo Blo ATL P/N 2700-0124

— ACM MONITOR —

— ALM MONITOR —

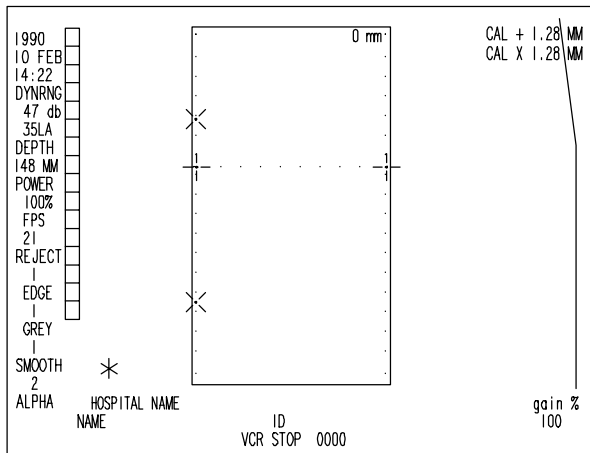
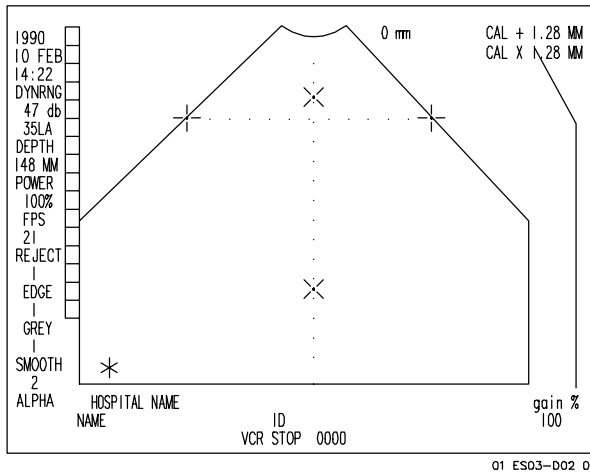
Figure 3-7. Aspect Ratio Test

- c. **ALM, 625-line video:** adjust R51 (Height), R39 (Top Linearity), and R35 (Bottom Linearity) until these calipers are the same distance apart as the “+” calipers (± 0.05).

5. Repeat width, height, centering and aspect ratio until no changes are necessary.
6. Verify that all graphics are visible on screen. (Date in upper left and “TGC PRESET” in lower right.)

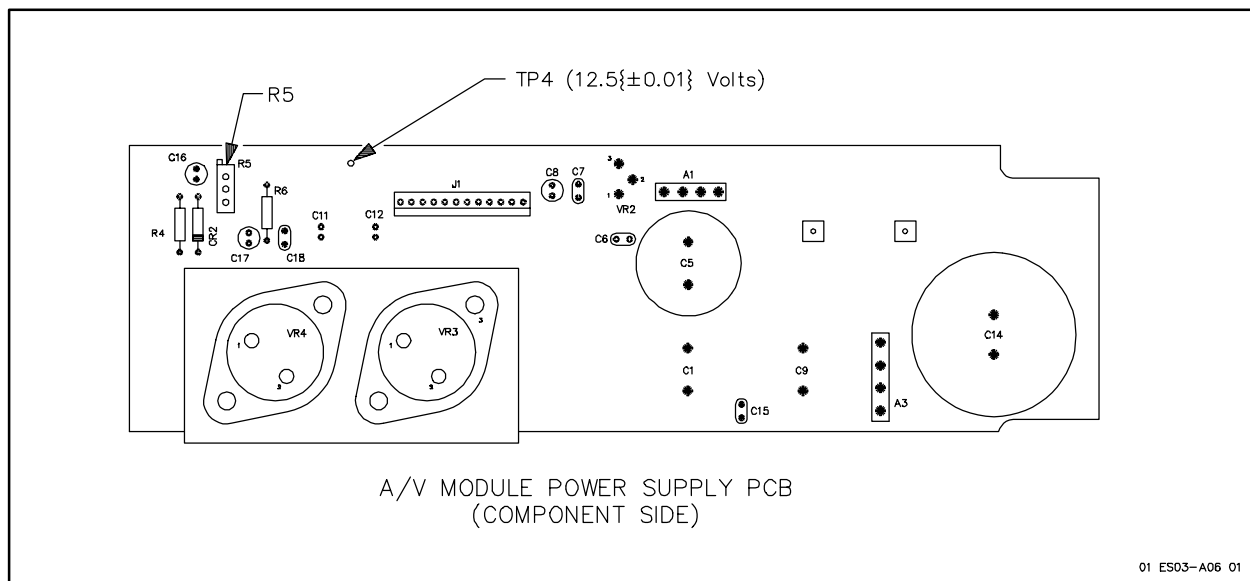
Figure 3-8. A/V Module Power Supply Adjustment Locations

1. Remove A/V Module from cart (Section 2E).
2. Remove cover on the A/V Module enclosure.
3. Connect DVM to test point TP4 and chassis ground.
4. Connect A/V Module to line power. Set system power to ON.
5. Adjust R5 (Figure 3-8) for 12.5 (± 0.01) volts. Power supply load is not required.

3-7 A/V Module (Figure 3-8)

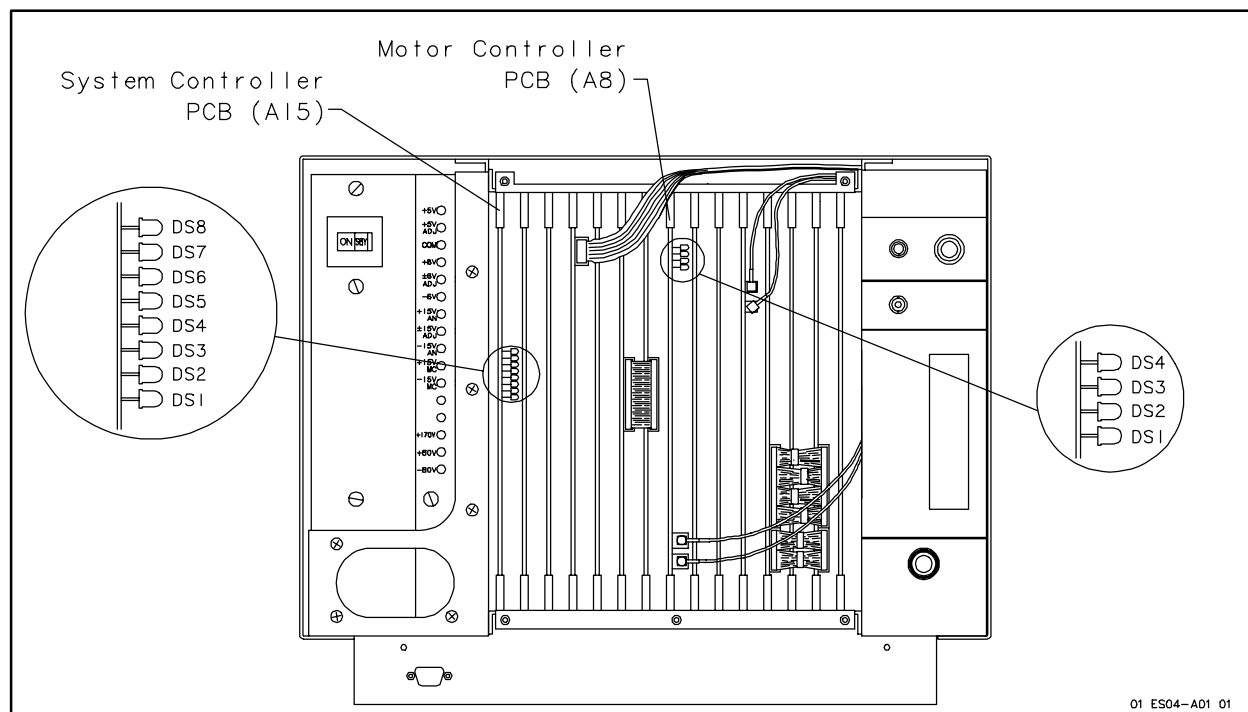
**Figure 4–1. PCB LED Indicators****4–4.2 System Controller LEDs**

The four LEDs on the Motor Controller PCB (DS1 through DS4) indicate the type of scanhead currently selected. This is a combined function of the input connector selected and the scanhead attached to that connector. [Table 4-1](#) interprets the legitimate combinations of LEDs. When the LED code does not correctly identify the scanhead connected and selected, verify that the problem is not restricted to a single scanhead. Continue by checking scanhead cables, and input connectors and associated wiring. If these are not the cause of the problem, replace the Motor Controller PCB.

DS1 (GRN)	DS2 (GRN)	DS3 (YEL)	DSR (RED)
DFT TRT (Linear) CVLA	ON	ON	ON	OFF

AA WAAA	OFF	OFF	ON	OFF
BFT EFT IVT TRT (Sector) ICT	ON	OFF	OFF	OFF
ACCESS 72B	OFF	ON	OFF	OFF

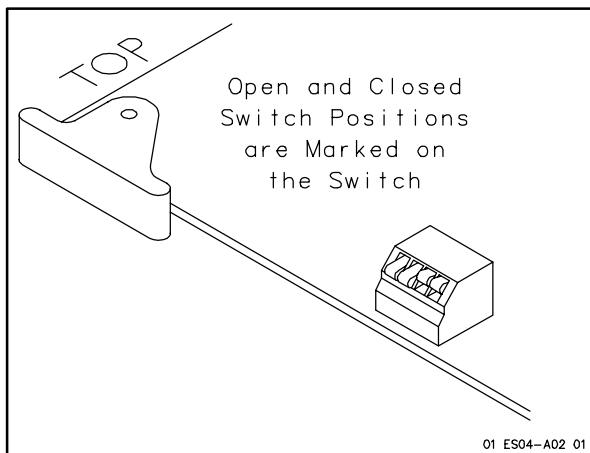
Figure 4-2. PCB Test Switches

Several PCBs in the card cage contain switches that are intended for use either in testing or system configuration or both (Figure 4-2). Switches on the TM-mode PCB, the TM Combo PCB and the Display Controller PCB inject specific test patterns into the data path at known points. If all processing circuitry is operating correctly, the test patterns will be displayed on the system monitor as in Figure 4-5 through Figure 4-7, and Figure 4-10.

NOTE: The switch package names are printed on the component side of the PCBs, adjacent to the switches. The numbers on the switch package itself denote the switches.

4-5 Test Switches (Figure 4-2)

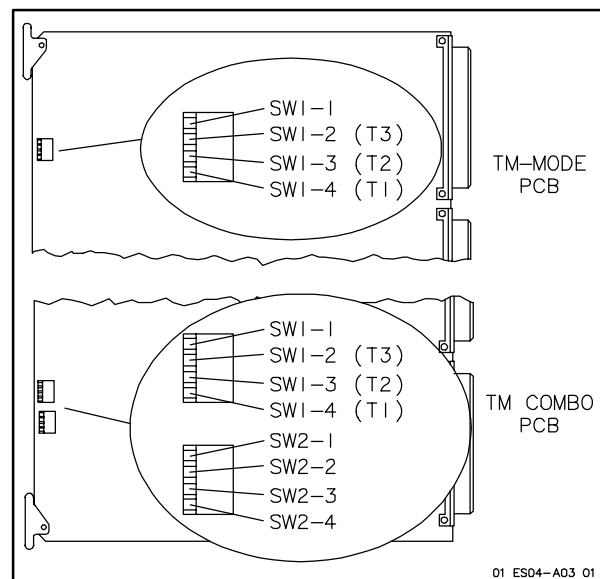
Figure 4-3. TM-mode Test Switch Location (Component side)

Test Switches S1-4 (T1), S1-3 (T2), and S1-3 (T3) of SW1 on the TM-mode and TM Combo PCBs inject test patterns into the inputs from the Pulse Processor and ECG box and the output of the M-mode Scan Converter, respectively. Their physical and electrical locations are shown in Figure 4-3 and Figure 4-4.

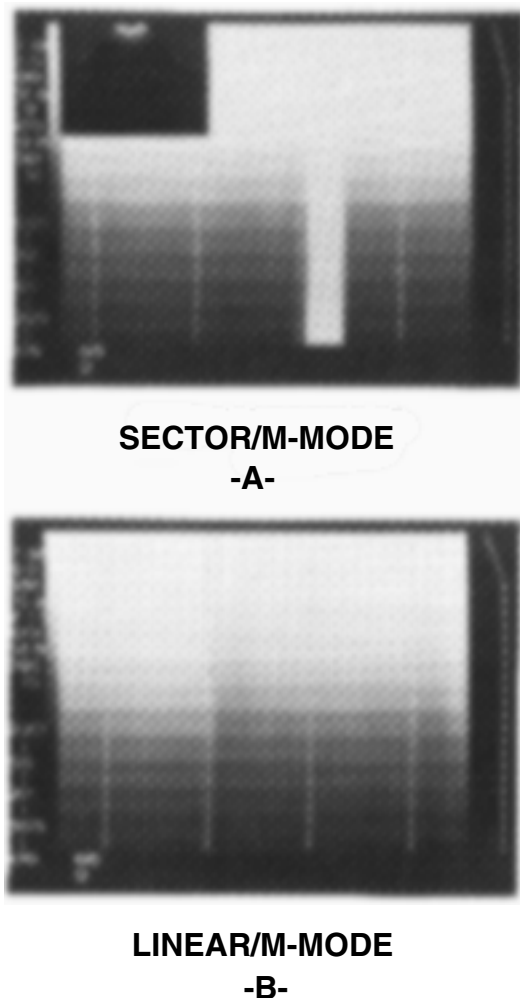
Figure 4-5. TM-mode Test One

This test injects a horizontal gray scale pattern into the input of the Scan Converter section of the TM-mode or TM Combo PCB. System must be in M-mode (from Sector or Linear). This tests the M-mode Scan Converter, the Display Group, Monitor and associated cables.

1. Set S1-4 (T1) to CLOSED.
2. Verify that a horizontal gray scale pattern is displayed (**Figure 4-5**).
3. Return S1-4 to OPEN.

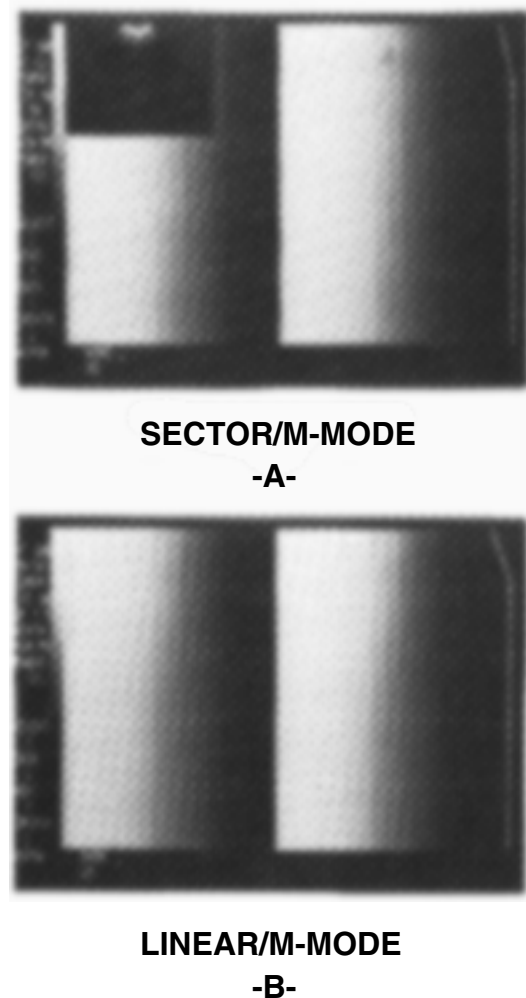
Figure 4-6. TM-mode Test Two

This test injects a vertical gray scale pattern into the output circuits of the TM-mode or TM Combo PCB. System must be in M-mode (from Sector or Linear). This tests the TM-mode PCB output, the Display Group, Monitor and associated cables.

1. Set S1-3 (T2) to CLOSED.
2. Verify that a vertical gray scale pattern is displayed (**Figure 4-6**).
3. Return S1-3 to OPEN.

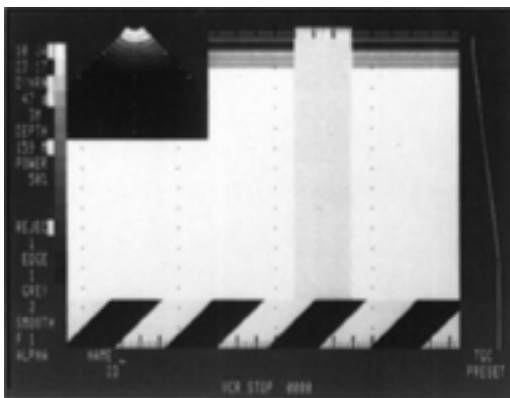
Figure 4-7. TM-mode Test Three

This test injects a diagonal black and white pattern into the ECG overlay circuit on the TM-mode or TM Combo PCB. System must be in M-mode (from Sector only); ECG must also be turned on from Control Panel. This isolates ECG problems to the ECG box and cables or to the TM-mode PCB if M-mode is operating normally (T1).

1. Set S1-1 to OPEN, S1-2 (T3) must be CLOSED.
2. Verify that a diagonal black and white pattern is displayed in the ECG window. (**Figure 4-7**).
3. Return S1-1 to CLOSED.

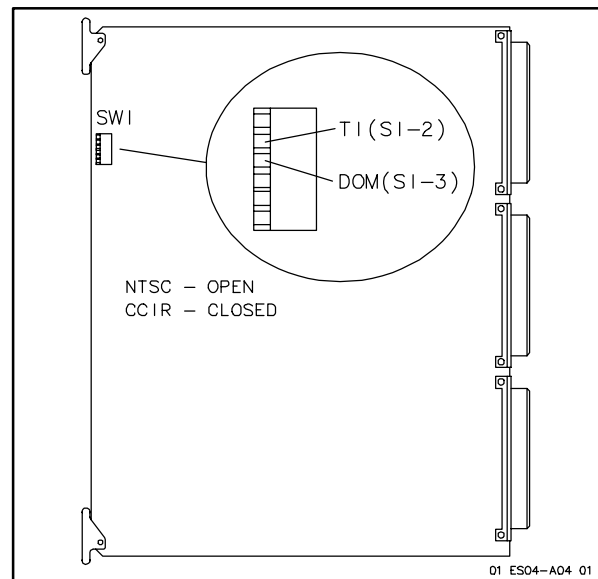
Figure 4-8. Display Controller Test Location

On the Display Controller PCB, only two switches are operational on SW1: S1-2 (labeled T1), and S1-3 (labeled DOM) (**Figure 4-8**). S1-2 (T1) injects a horizontal gray scale pattern into the input of the Display Controller PCB (either mode). The point at which the test signal is injected into the circuit is shown in **Figure 4-9**. S1-3 (DOM) is set to configure the system's video format for either NTSC (OPEN) or CCIR (CLOSED).

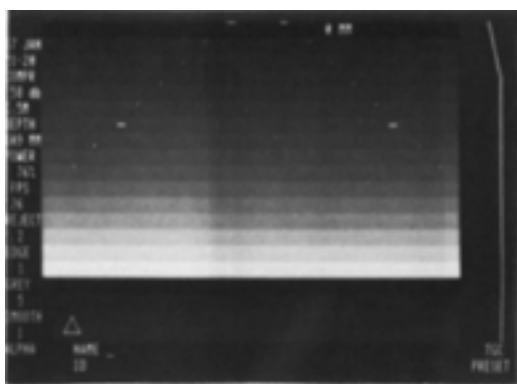
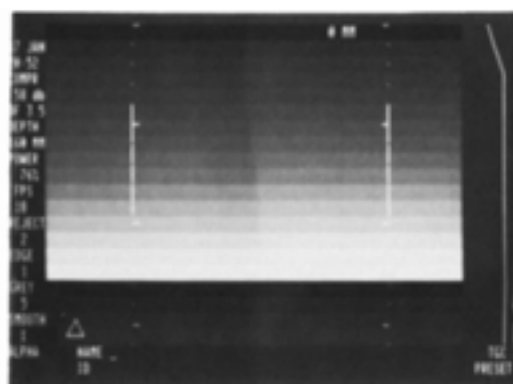
Figure 4-10. Display Controller Test One

1. Set S1-2 (T1) to CLOSED.
2. Verify that a horizontal gray scale pattern is displayed (**Figure 4-10**).
3. Return S1-2 to OPEN.

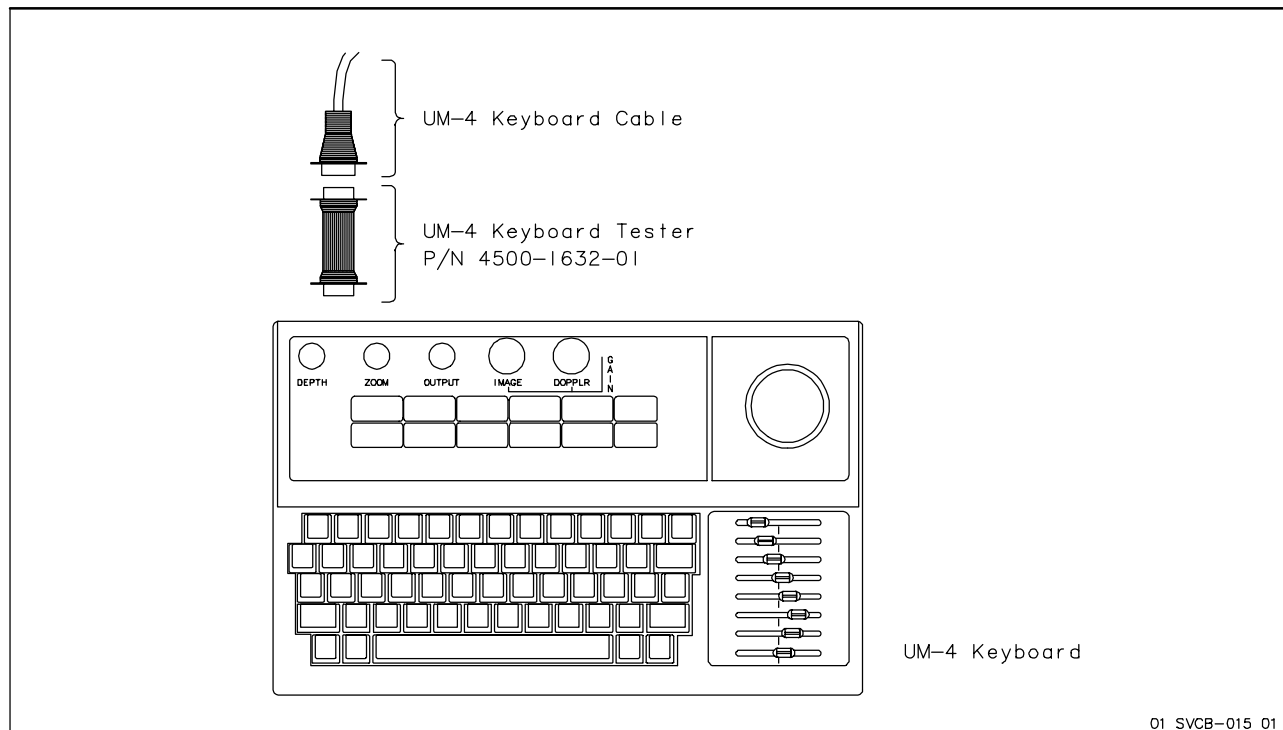
Figure 4-12. UM-4 Keyboard Tester

1. With the system OFF, insert and secure the tester in series with the keyboard cable and the keyboard.
2. Turn the system ON.
3. Follow the prompts on the keyboard display. (A test selection menu will be displayed after the initial softkey test. Disregard the HARDKEY selection on this menu.)

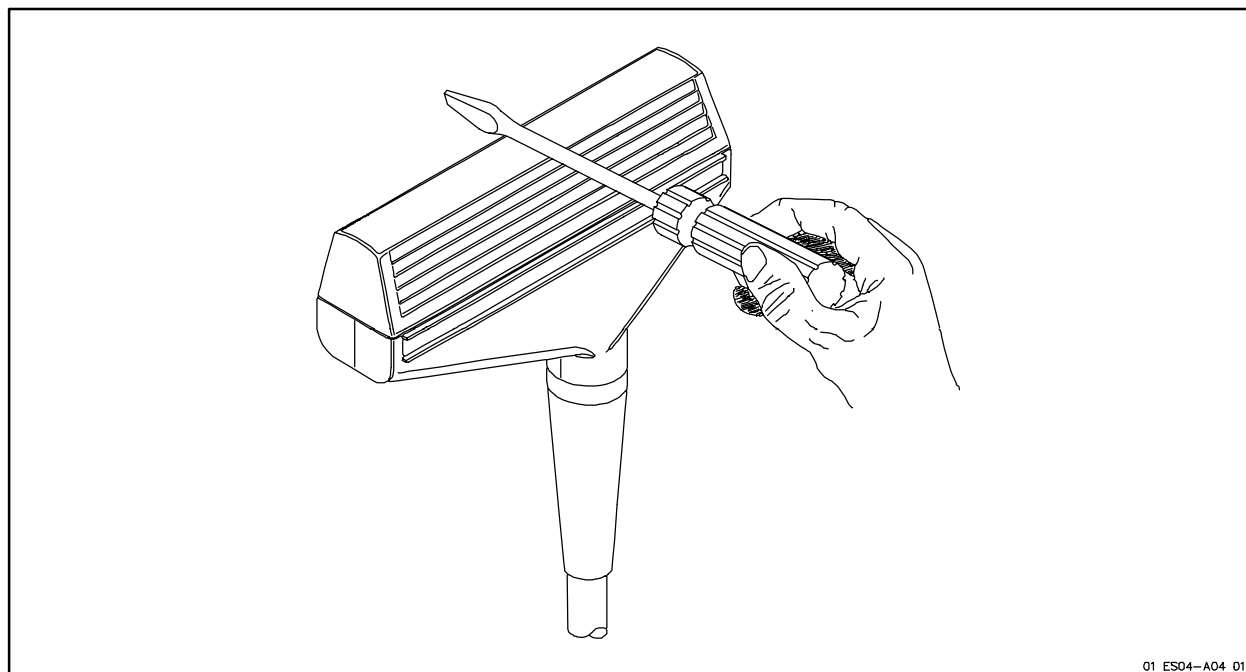
Figure 4-13. Tower Test

5. Examine the surface of the scanhead for any physical defects (replace the scanhead if any are found).
6. Lightly coat the surface with acoustic gel.
7. Hold a thin screwdriver perpendicular to the surface of the scanhead and slowly slide it down the scanhead using minimal pressure on the screwdriver ([Figure 4-13](#)).
 - The tower-like image should have five separate sections (widths). Only one tower should be displayed.

12. Perform the tower tests again. If the problem still exists, replace the A2, A3, A4 PCBs:
 - a. If a single dropout occurs, the problem is most likely to be a scanhead;

- b. If four dropouts, probably Beam-former Focus PCB (A3);
 - c. If eight dropouts, probably Front End PCB (A2).

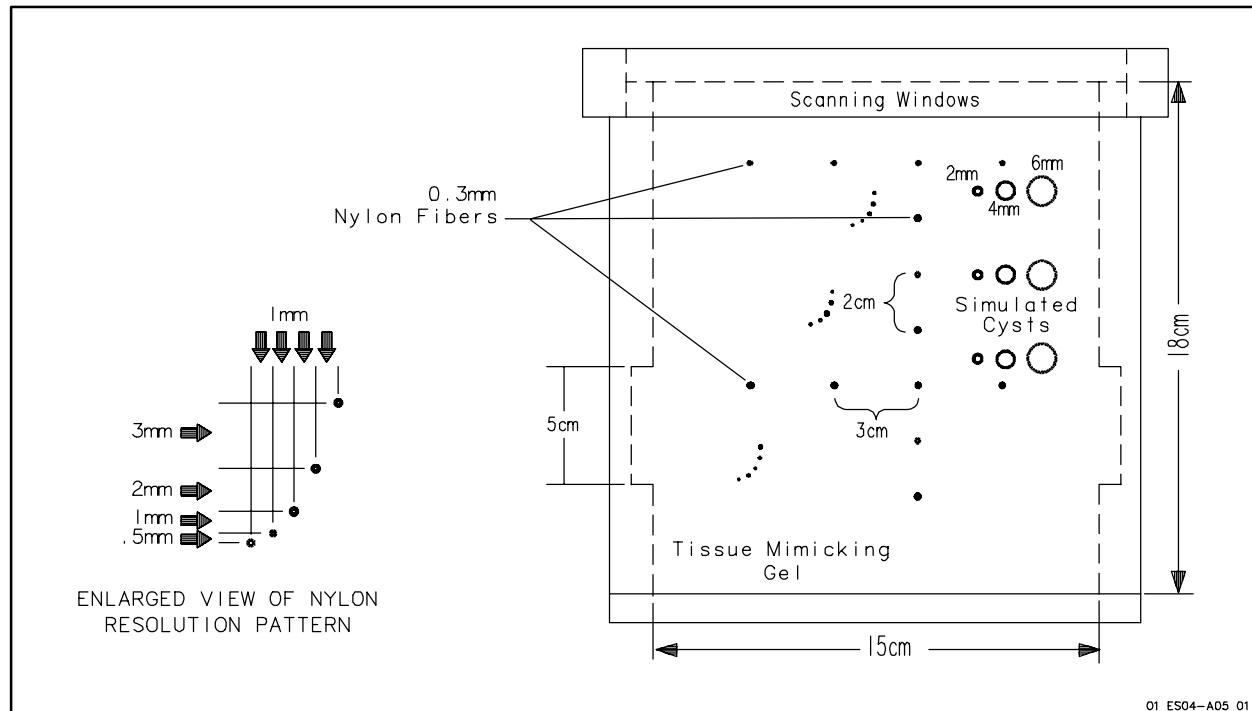
Figure 4-14. RM 413A Phantom Geometry

1. Measure axial resolution with the pin groups at 3, 7, and 12 cm depths on the phantom (see enlargement in [Figure 4-14](#)).
 - Optimize the display of each pin group by adjusting image controls and scanhead transmit focal zones.
 - The bottom pins in each set are vertically separated by 0.5 mm. If they can be distinguished from each other, the axial resolution is 0.5 mm.
 - Determine the closest two pins that can be clearly distinguished (separated vertically from other pins in the same group).
 - Determine axial resolution for each depth (3, 7, and 12 cm).
2. The scanhead(s) axial resolutions should meet the specifications listed in the appropriate scanhead table in [Section 2C, Performance Tests](#).

1. Measure axial resolution with the pin groups at 3, 7, and 12 cm depths on the phantom (see enlargement in [Figure 4-14](#)).
 - Optimize the display of each pin group by adjusting image controls and scanhead transmit focal zones.
 - The bottom pins in each set are vertically separated by 0.5 mm. If they can be distinguished from each other, the axial resolution is 0.5 mm.
 - Determine the closest two pins that can be clearly distinguished (separated vertically from other pins in the same group).
 - Determine axial resolution for each depth (3, 7, and 12 cm).
2. The scanhead(s) axial resolution should meet the specifications listed in the appropriate scanhead table in [Section 2C, Performance Tests](#).

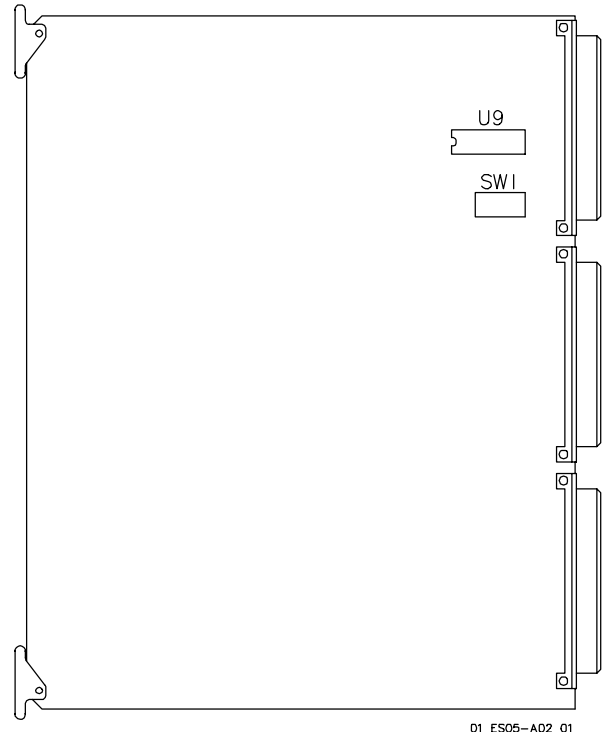
**Doppler Pulser (A1)
7500-0369-XX**

NOTE: There are no PROMs for the Doppler Pulser PCB.

NOTE: There are no jumpers or switches on 7500-0525-XX PCBs.

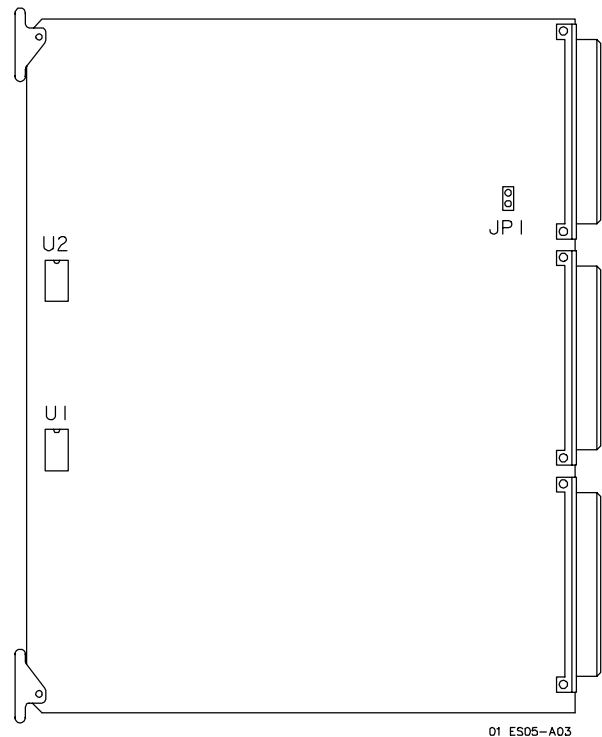
**BEAMFORMER FOCUS (A3)
7500-0320-XX; 7500-0361-XX**

NOTE: There are no PROMs for Beamformer Focus PCB.

NOTE: There are no jumpers on 7500-0549-XX.

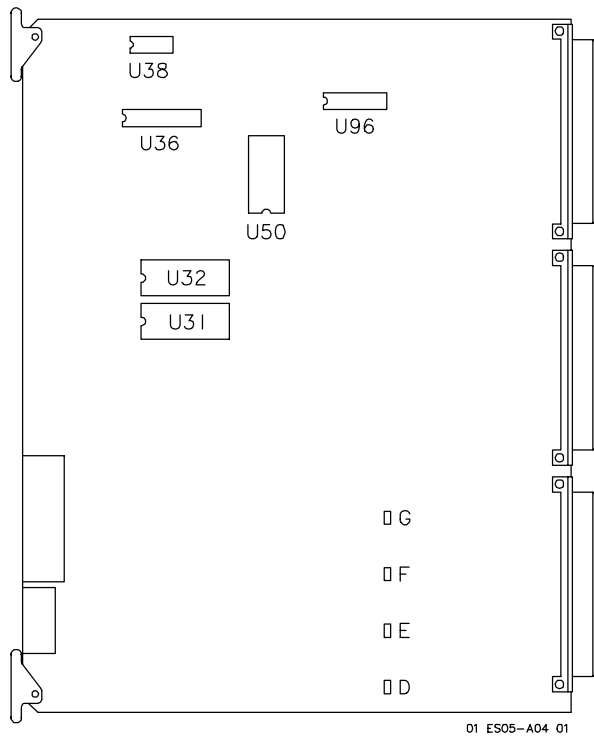
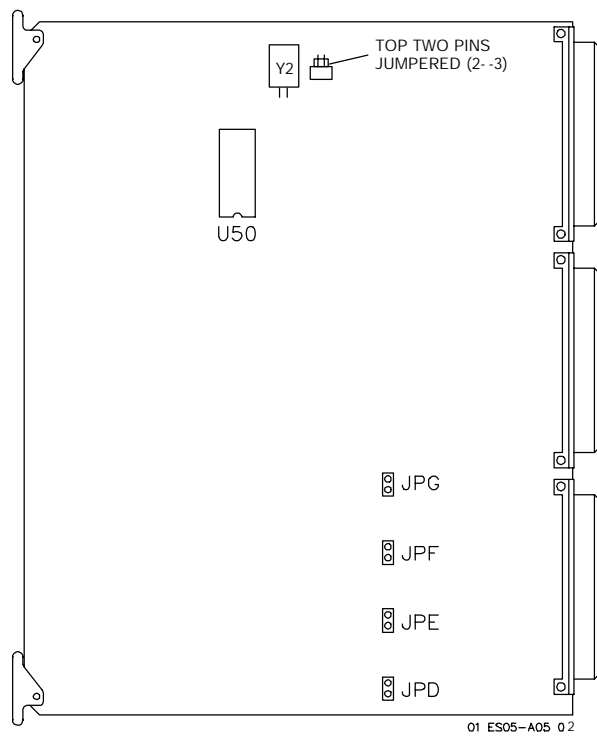
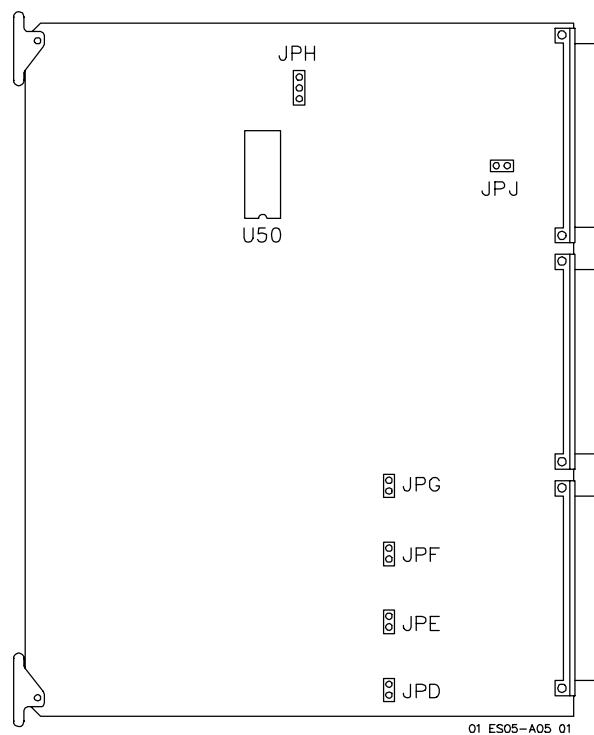
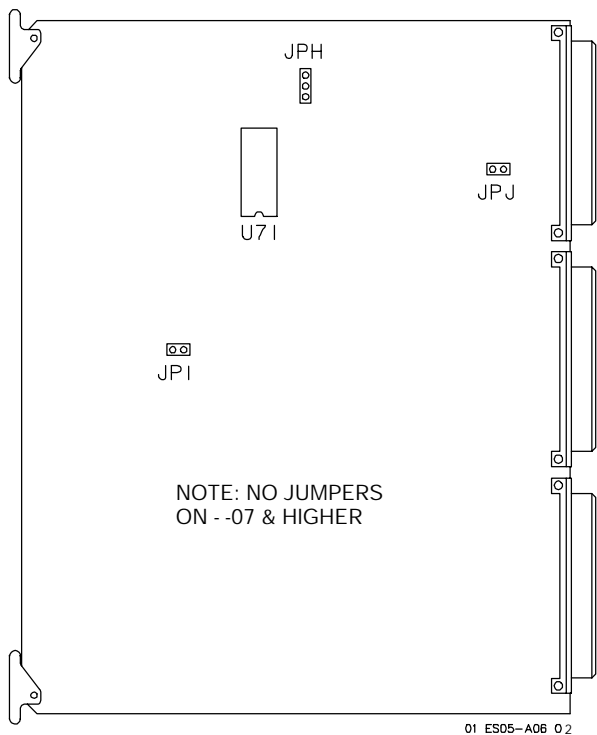
PCB		JUMPER OR SWITCH				
Part No.	Dash No.	Ref. Des.	Pins	Function	Normal Position	Notes
7500-0362	ALL	D	1-2	Test	Shorted	
		E	1-2	Test	Shorted	
		F	1-2	Test	Shorted	
		G	1-2	Test	Shorted	
	01 and above	JPH	1-2	Non-Sync	Open	Sync/Non-Sync conversion requires more than JP-H change, refer to Up/Down Rev Instructions.
			2-3	Sync	Shorted	
		All others			Open	
7500-0548 ¹	06 and below	JPI	1-2	Write to PROM	Open	
			2-3	Read PROM	Shorted	
		JPH	1-2	Internal clock	Open	Non-Sync
			2-3	External clock	Shorted	Sync
		JPJ	1-2	N/A	Open

**BEAMFORMER CONTROLLER (A4)
7500-0324-XX (S1 ONLY)**

**BEAMFORMER CONTROLLER (A4)
7500-0362-04 & Lower**

**BEAMFORMER CONTROLLER (A4)
7500-0362-05 & higher**

**BEAMFORMER CONTROLLER (A4)
7500-0548-XX**
